Close Out Report
On works completed aboard the
MTR2
For Mermaid Drilling
By
Chemco Specialty Coatings
Contractor and Supplier:
Refurbishment of Upper Accomadation Deck
Using Sandwich Laminating System
To Recover Deck
Work Completed January - April 2013
Report by
Bill Bradnick
Technical Director

Mermaid Drilling Limited
MTR-2
IMO # 7533408
Gross Tonnage 7989
Ernie Pan

Report on Refurbishment of Accomadation Deck

Aboard the MTR2

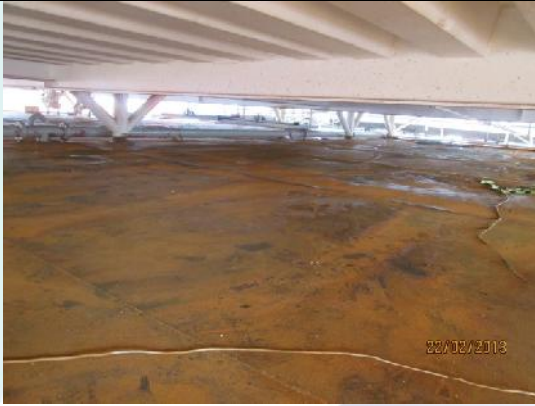
Pic 1: Surface Before the treatment after the high pressure water blast as carried out by the shipyard.

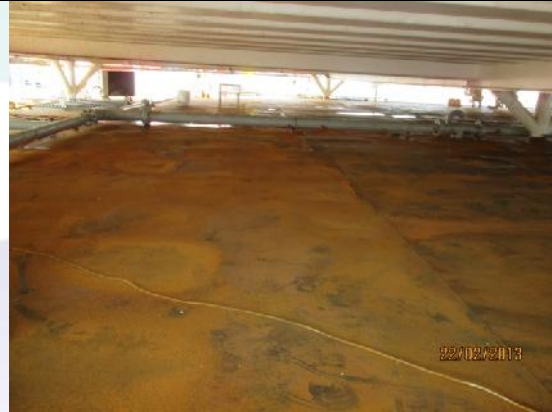
Pic 2: As per previous pic, surface oxidization had reached critical levels over two week period must be removed.

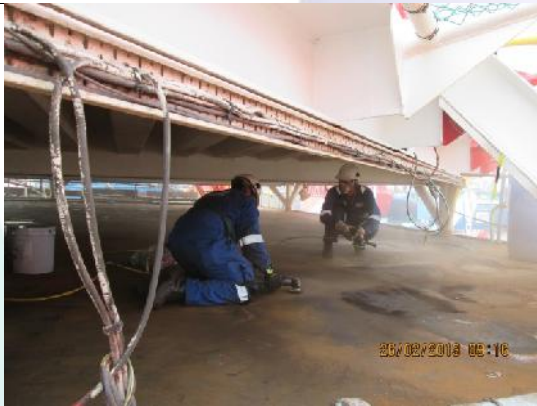
Pic 3: Air Powered Twist knot wire brushes were used to remove the build-up of oxidisation that had occurred.

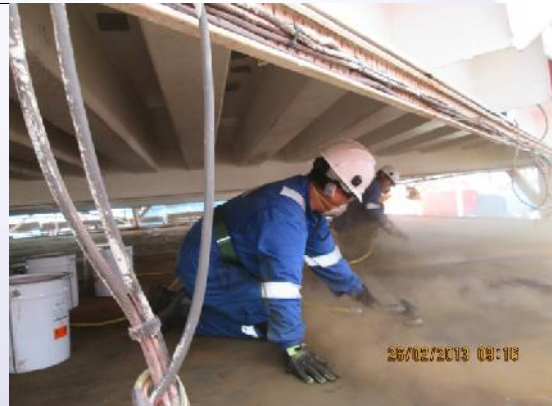
Pic 4: Heavy Oxidisation being removed by Power Wire Brush ready to prime after washing

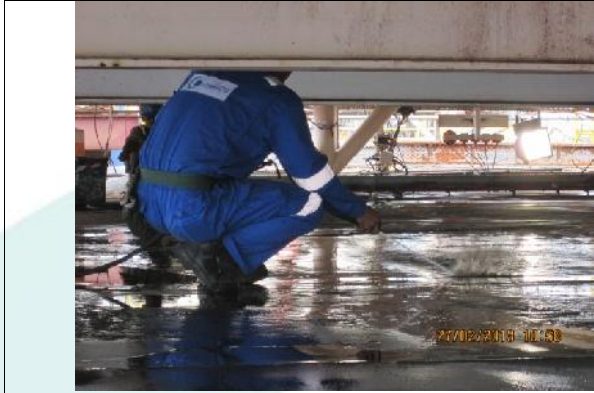
Pic 5: Washing the deck after the Power wire brushing was complete

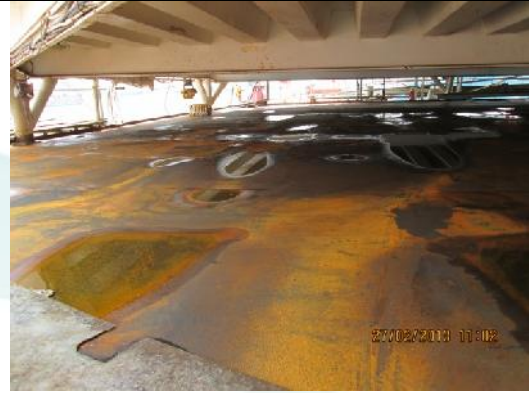
Pic 6: After wash surface ready to prime with Chemco RS 500P

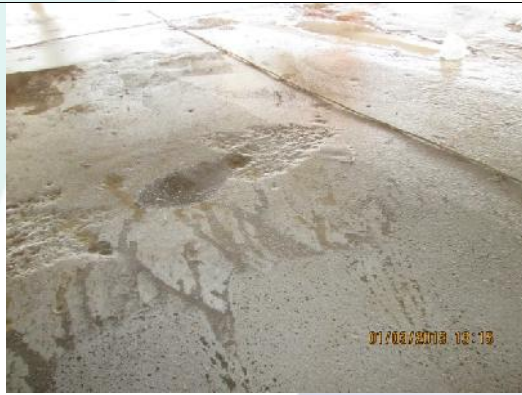
Pic 7: Surface pitting severe in several places.

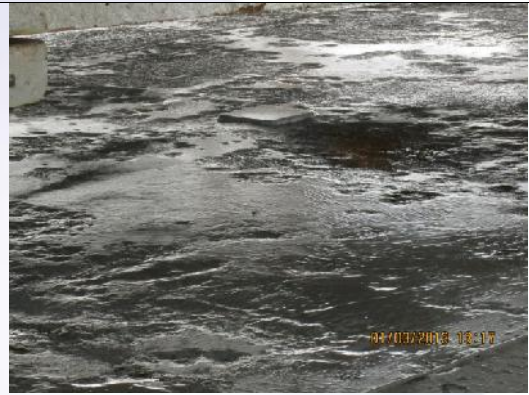
Pic 8: Surface looks like the moon it is so pitted.

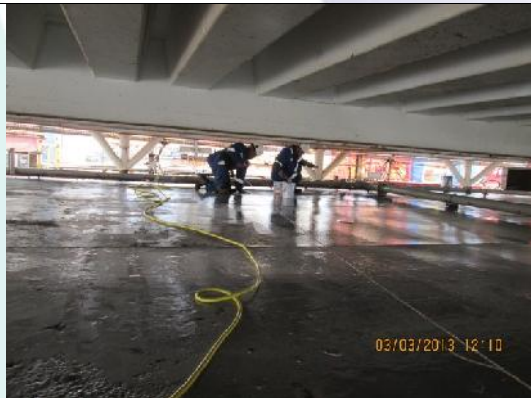
Pic 9: Priming of surface in progress.

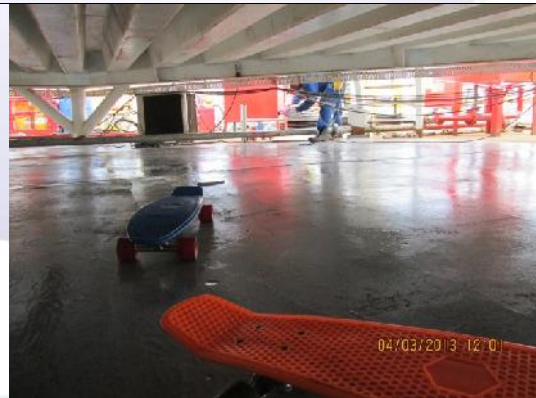
Pic 10: Primed surface with transport system on view. Provided mobility in tight area.

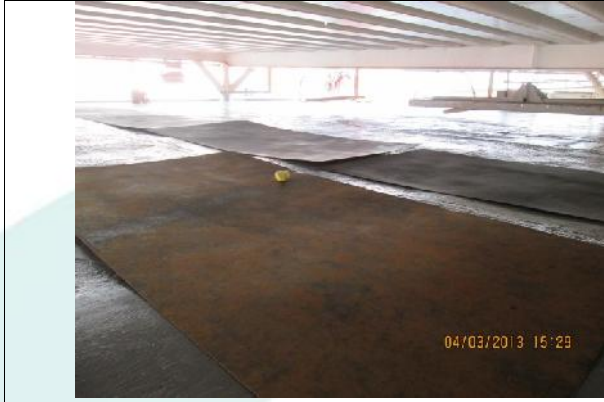
Pic 11: Plates bought on to site they have been blasted on the side facing the deck, for maximum adhesion

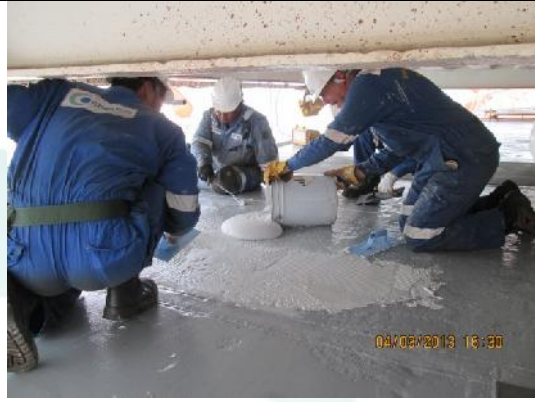
Pic 12: First step in preparation for the plate apply a bed of wet material suitably prepared, the men call this "mud"

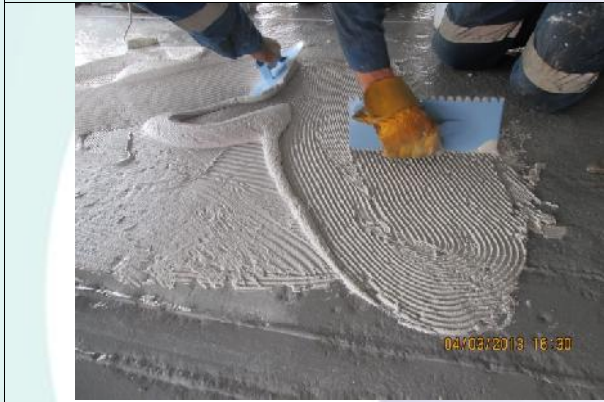
Pic 13: Notched trowel used to spread the mud evenly.

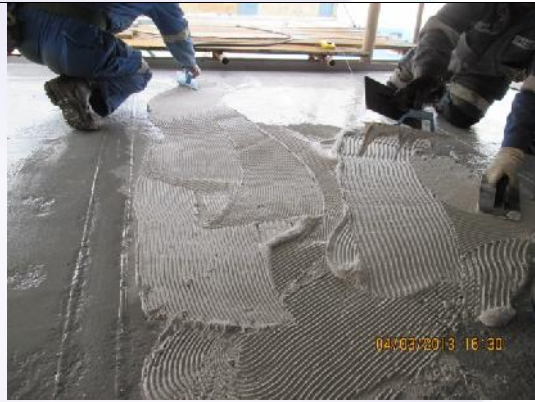
Pic 14: The entire surface has the mud applied, the plate is applied whilst the mud is still wet forming 100% glue line

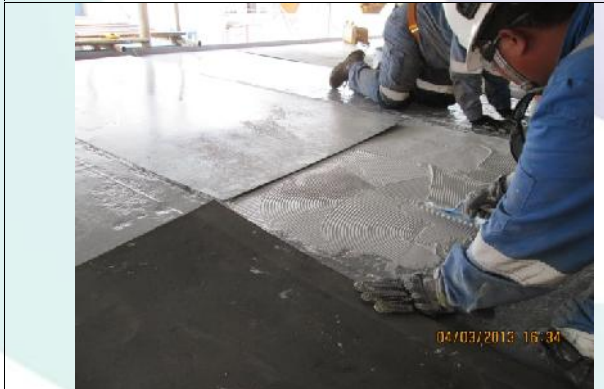
Pic 14: Plate ready for laying down onto bed whilst it is wet,

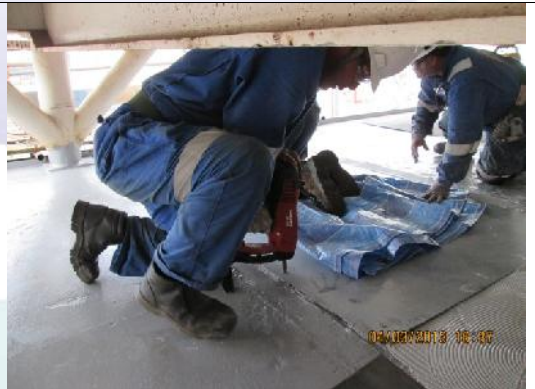
Pic 15: Gunning the first plate down using the Hilti Compressed Air Gun model GX120.

The anchoring was accomplished using the HILTI gun to quickly install pins that were used as the primary anchor.

It was decided to drive the pins through the entire fabrication thus directly securing the 2mm plate to the deck through the fill which was placed on the wet deck surface.

The force applied drove the pin entirely through the 2mm plate with sufficient impingement in the substrate to the extent that even with a lever it was impossible to remove. The plates when combined with the anchors securing them in this way and the very high adhesion of the RA500M filler used, is a very permanent repair. The application of the lamination system also has an important part to play in the securing of the entire system both to the deck and the bonded plates

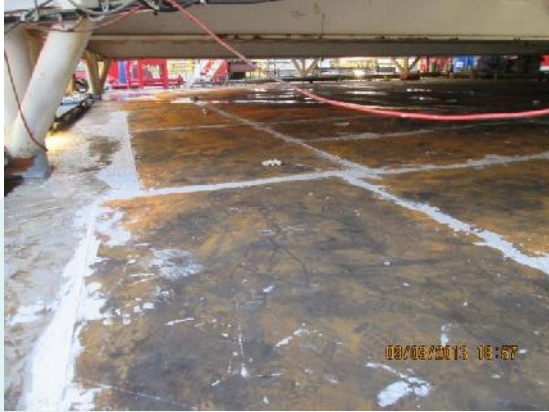
Pic 16: Plates laid to over 80% of the surface area.

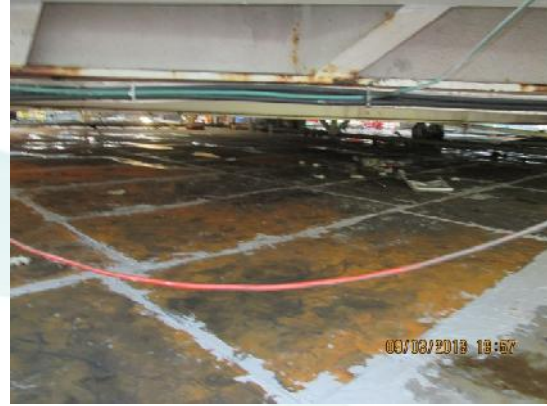
Pic 17: Plates laid over wide area not the glue line between plates ensuring full bonding even on the edge.

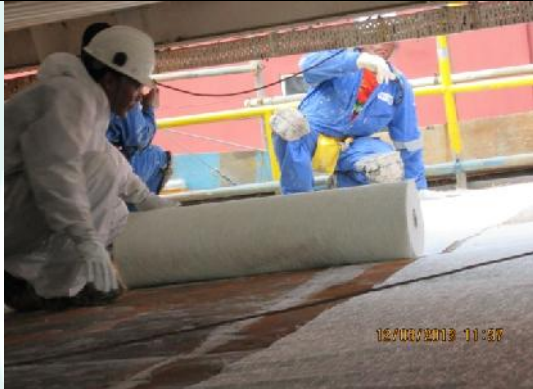
Pic 18: The First Laminating Cloth laid out

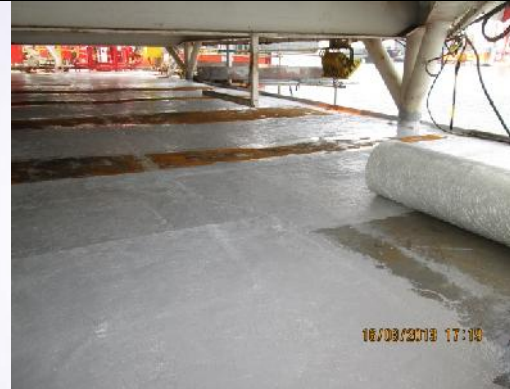
Pic 19: Laminating completed in every second strip to give access whilst the application is on-going.

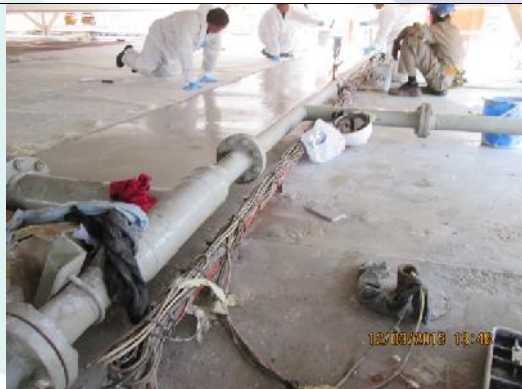
Pic 20: Laminating in action, shipyard assistance present.

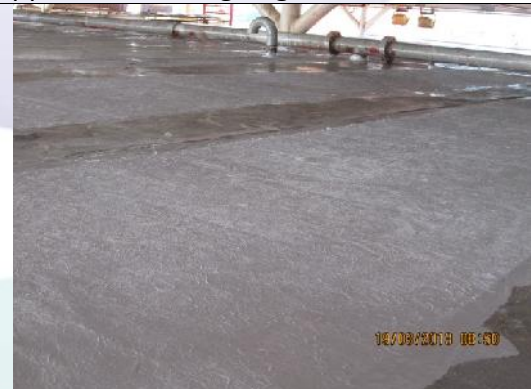
Pic 21: Completed surface ready for next process.

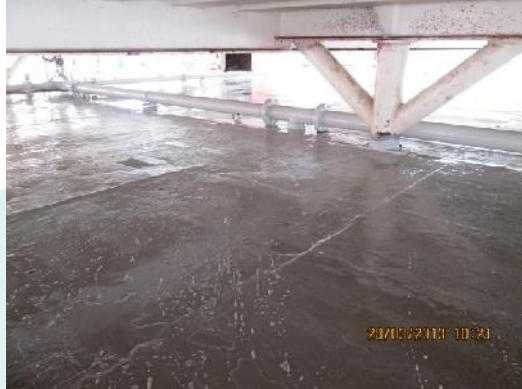
Pic 23 Completed work after top coat just prior to Vacuum test

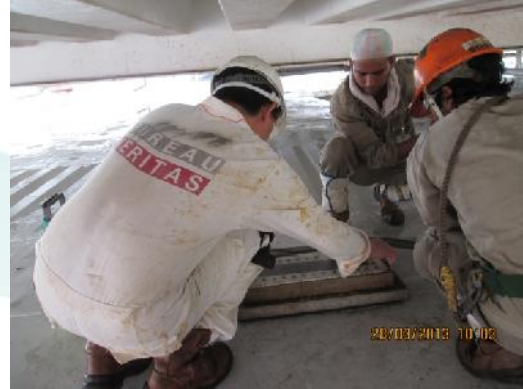
Pic 24: Vacuum Test in action with BV inspector present...passed the test!

- There are some areas where water ponding will be possible, but this will have no effect on the coating/laminating system, it is totally waterproof and suitable for a tank lining as fully submerged!
- This repair is a long term repair that will see the life of the MTR2 out in our opinion.
- This repair has passed a Vacuum Test as conducted by Mr. Clive Fok, Marine Surveyor Bureau Veritas Marine (Singapore) Pte Ltd.

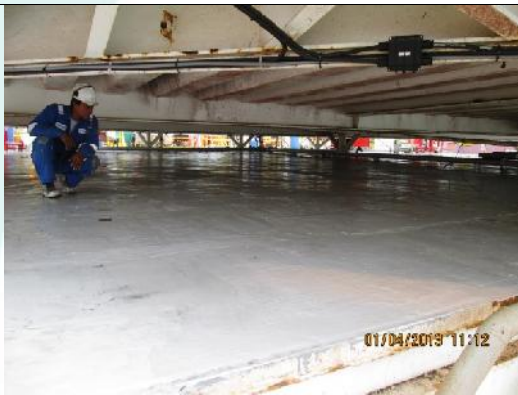
Pic 25: Finished Work Completed after testing ready for service

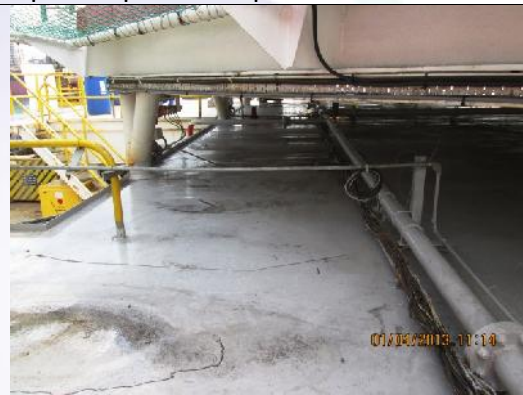
Pic 26: Finished Work Completed after testing ready for service.

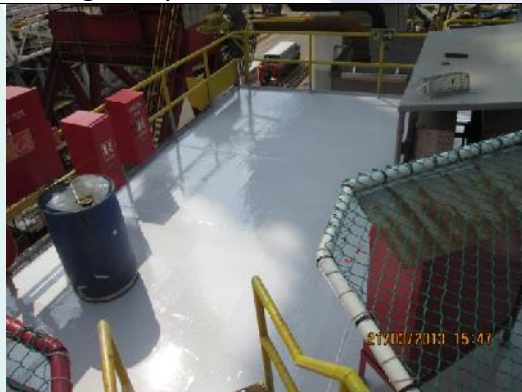
Pic 27: Several other external areas were completed to finish off entire deck

The heavily corroded coving was rebuilt using this system and other outer deck area was also coated as part of this process.
